Gjirokastër fortress hillside. Geotechnical hazards assessment and stabilization measures as key factors for the fortress preservation.

Endri Duro

PhD researcher / POLIS University

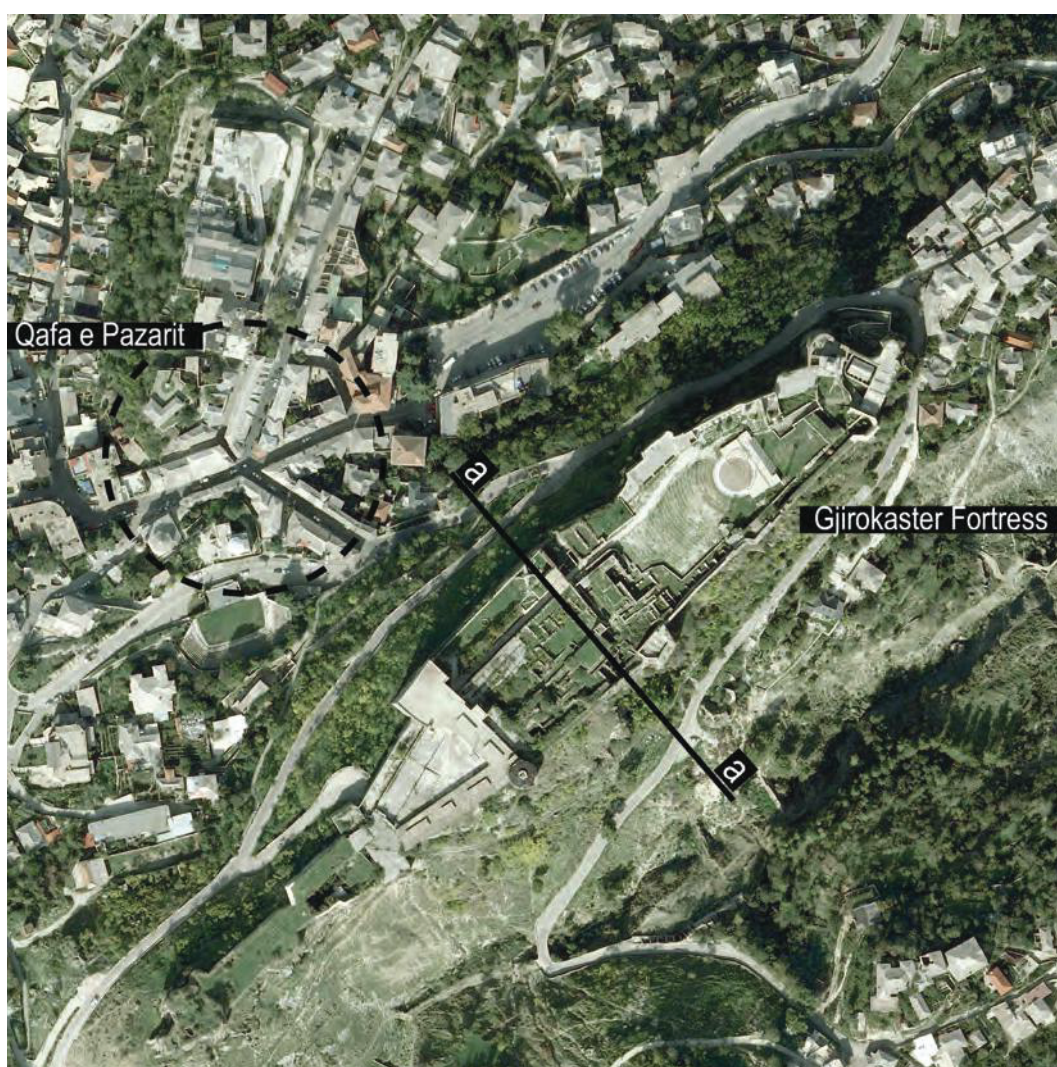
Fig. 2 / Topographical configuration of the fortress area (up) and aerial view of the zone together with the cross- section to be studied (down) (adaptation from the work of Eng. Adriatik Kodra.

A topographical map gives detailed information regarding the configuration of the city in altitude. In order to properly analyze the slope stability a cross-section needs to be generated from the topographical map.

An approximate geological profile for the section a-a shown in Fig2. was elaborated using rough experiences from past studies which show that the fortress itself stands on a strong and well cemented conglomerate with some joints present and a height of around 20-30 meters. Below the conglomerate there are flysch deposits of mainly sandstone and claystone, and on both sides of the hill, just above the flysch, there are deposits of loose to medium dense brown to beige silty clay with a height varying from 3 to 4 meters. The geological configuration

The analysis was performed in three stages: in the first one, the geometry of the slope was generated using the topography, in the second stage all the soil and rock parameters determined in Table 2 were inputted and assigned to the proper layers. In the final stage, according to Fig 2, the analysis was performed using the auto grid option in which a grid of 20 by 20 points was created with the aim of generating a large number of points that serve as centers of potential slip surfaces, each one of them having a different radius. The analysis's results showed that the lowest factor of safety is 1.137, which corresponds to a slip surface passing through the silty clay deposit. By applying a filter for the slip surfaces with a factor of safety lower than 1.2, it can be clearly observed that there are many dangerous surfaces along the conglomerate and flysch deposits too.
