# Erosion and industrial pollution of Seman River

*Prof Dr Sherif Lushaj*

*Dean of Urban Planning faculty / POLIS University Tirana*

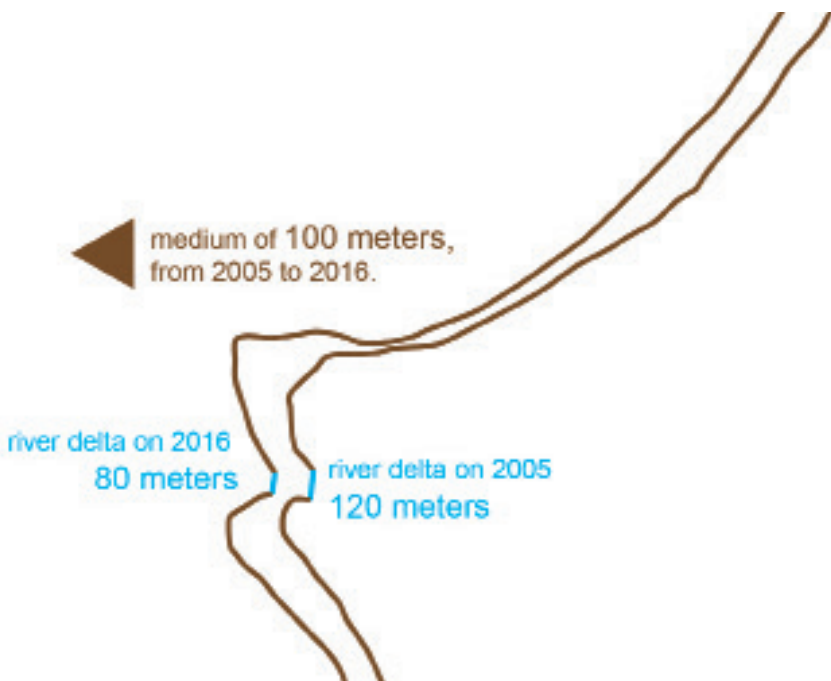
Fig2 / Change of the river mouth.  
source / drawing by Artan Kacani

The Seman River from 1870-1990 has changed its delta 6 times, in average every 18-22 years. In the same period the coast has been eroded along 3-7km. The turbidity changed in 1918, 1924-1925, 1937, 1957, 1978. With the construction of the Karavasta hydropower plant, erosion intensity on the coastline increased from 15 to 35m per year. Seman's beach was build during the years 1958-1962 in an area with distinctive erosion phenomena. Some years after the construction it was further destroyed by coastal erosion and the advancement of the sea to the land. In 1957, the river delta moved 4.6 km to the south. In 1978, the river was divided into two parts 6km south of the 1957 site, located 2 km away from each other, advancing inland. While in 1990, the river mouth compared to 1978, has advanced toward the south. These moves have caused changes in the coastal line as well as have simulate coastal erosion, with sea advancement towards the land in some segments, and land advancement towards the see in other segments.
