**TITLE: Erosion and industrial pollution of Seman River**

**AUTHOR: *Prof Dr Sherif Lushaj***  
**SOURCE: *Scientific journal of the Observatory of Mediterranean Basin,  
Volume 3 / 2016, pp. 48-57***

# Erosion and industrial pollution of Seman River

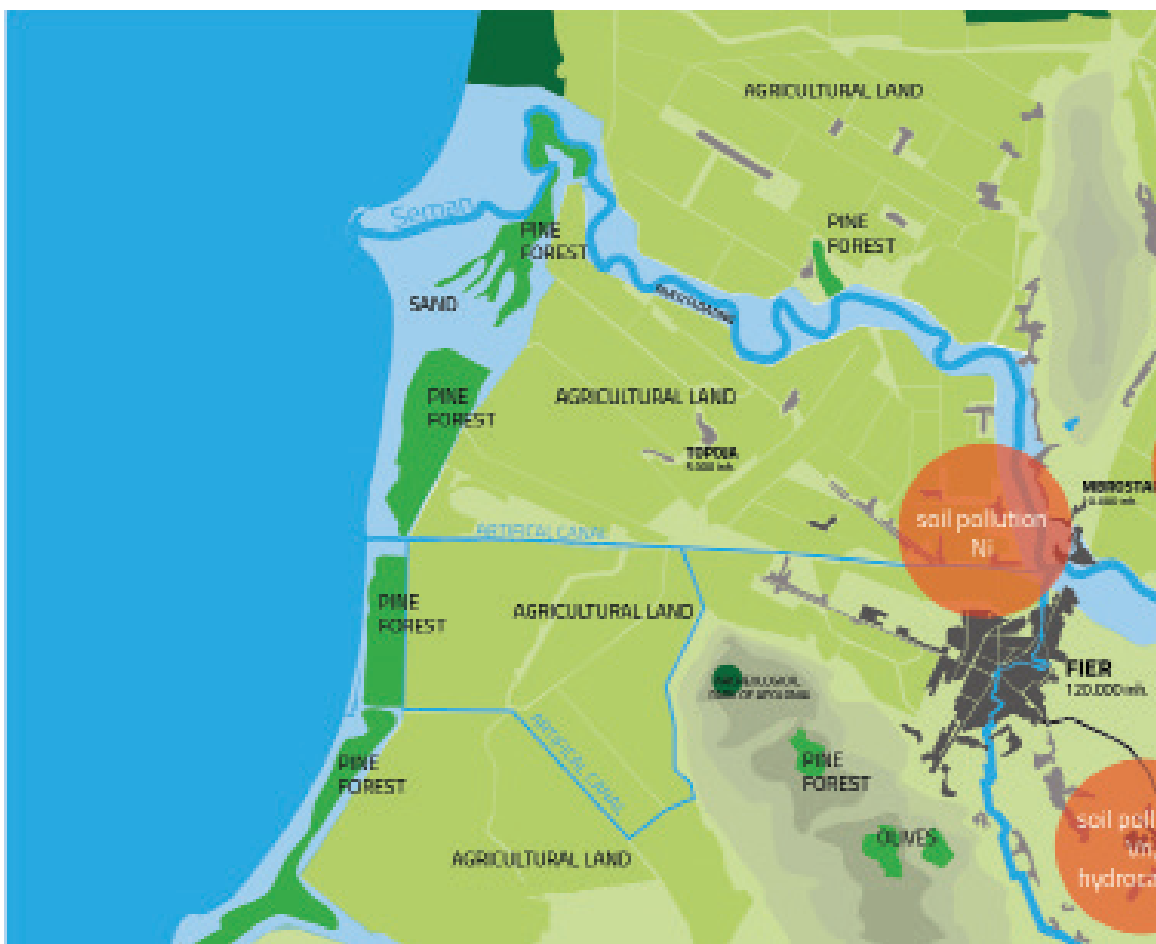
This data shows that the content of Ni, Vn and hydrocarbons in the soil is high, compared to the allowed levels of Ni, Pb, Cr, hydrocarbons. In other sampling places, land analysis shows a high content of heavy metals. In the Marinza lands close to the oil wells, Nickel content is (Ni)

630 ppm and lead (pb) 359 ppm. While in Ura Vajgurore, close to the oil well area, the Ni content ranges from 360-410 ppm and lead (pb) 347-365 ppm. The outbreak of hydrocarbons has contributed to the general damage of the living world or the removal to other aquatic environments. Seman River water was used for irrigation of agricultural lands and the amount of hydrocarbons in the soil has increased. The three-point systematic analysis (Vajgurore Bridge, Kuc's Bridge and Mbrostar Bridge) shows the Seman River pollution from the over allowed limits of hydrocarbons, to the damage of water biodiversity.

From the oil processing plant in Ballsh and Patos-Marinza, the residues of hydrocarbons with high content of toxic substances are discharged to the Gjanica River and then flowed to the Semani River, with direct impacts on river fauna and the quality of groundwater. According to the calculations (based on the level of inflows and concentration of water contaminants) it results that the Gjanica River transports more than 10 thousand  $\text{m}^3$  of liquid waste (hydrocarbons and industrial), causing deterioration of the biodiversity and water quality, and soil damage. Monitoring on agricultural lands in the Kuçovë-Patos-Marinza oil field and around Ballsh oil processing plant, in the depth of 0-30cm, shows that the content of Ni, Pb, Cr, Vn (vanadium) and hydrocarbons as contaminant Oil extraction activity have a high concentration.

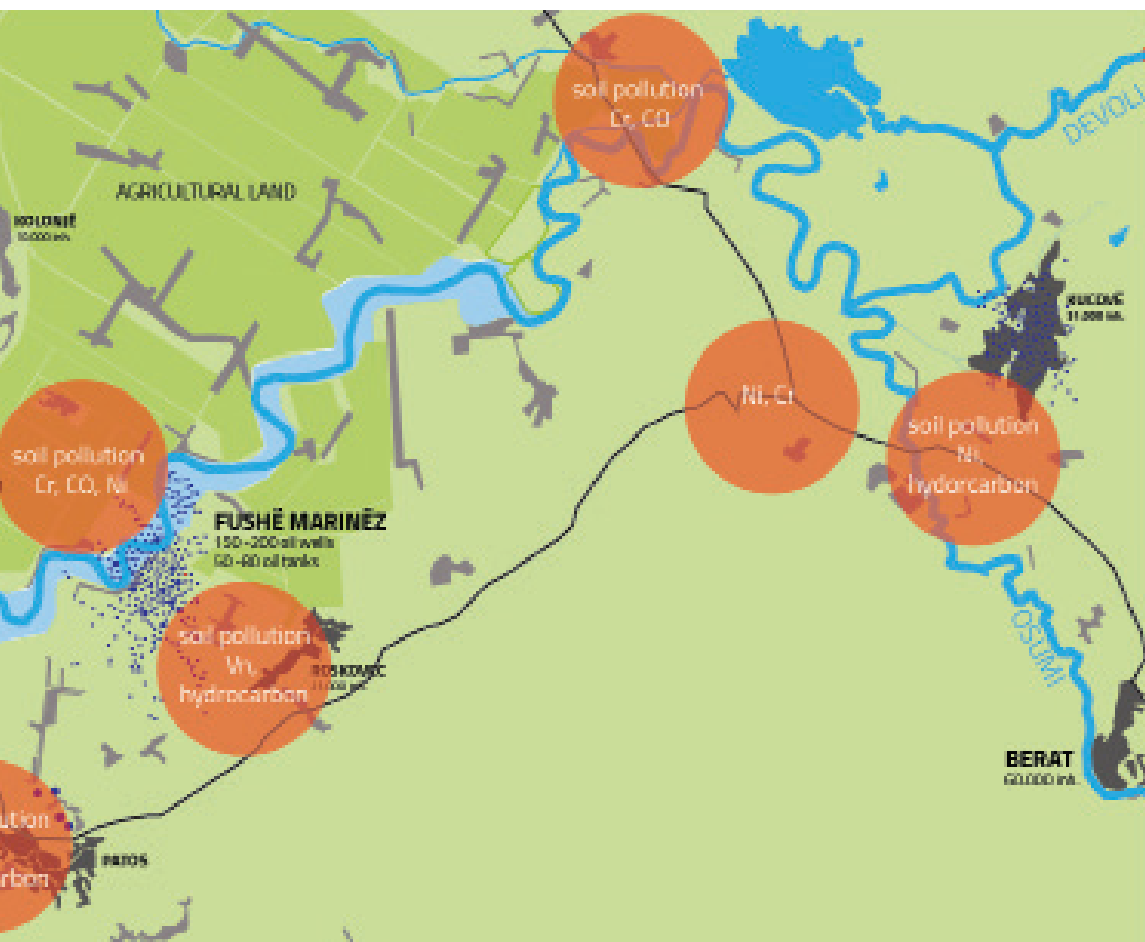
Fig4 / Soil pollution map, source / drawing by Artan Kacani

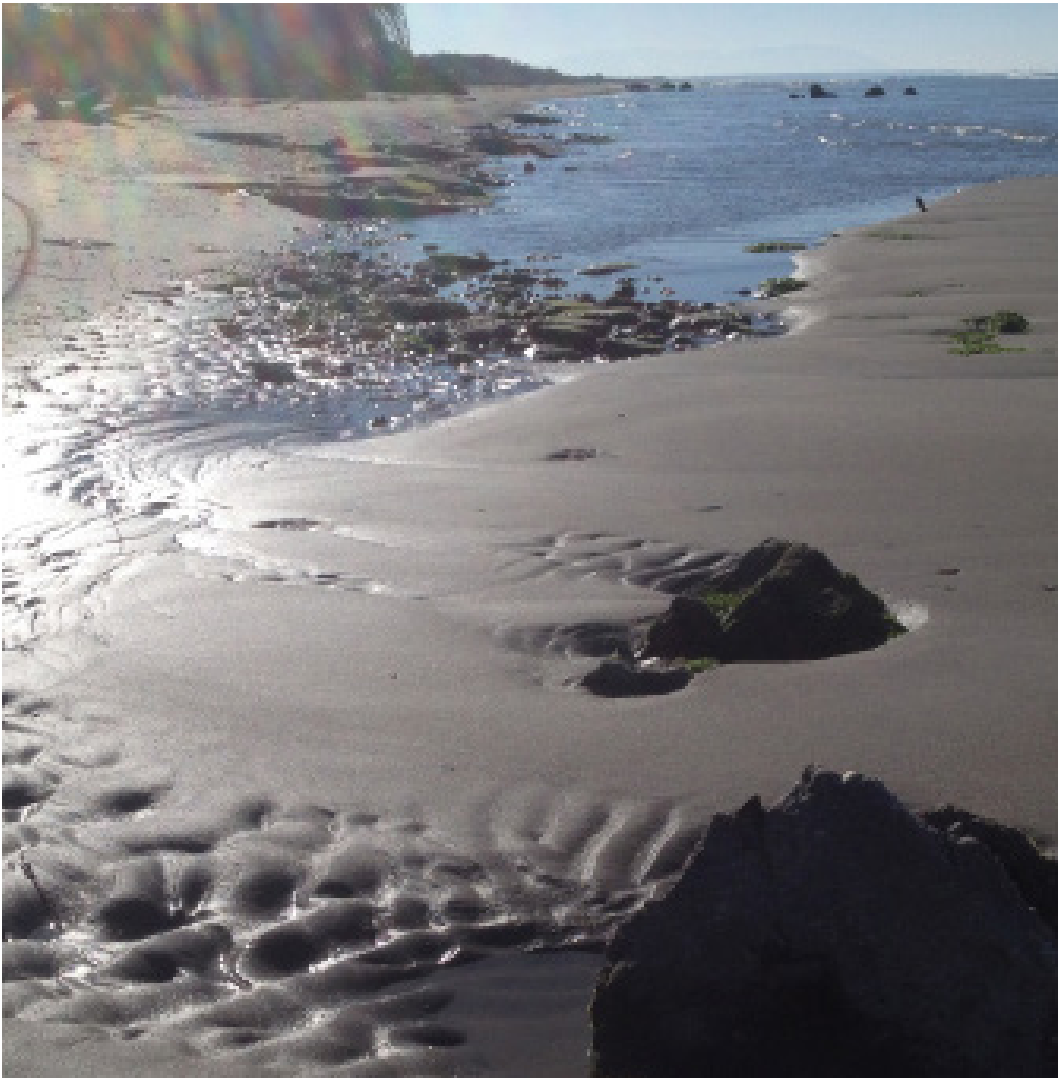
*Fig / Sedimentation in the Semani River Delta source / Vezir Muharremaj*
