TITLE: **Gjirokastër fortress hillside.
Geotechnical hazards assessment and stabilization measures as key factors for the fortress preservation**

AUTHOR: *Endri Duro*

SOURCE: *Scientific journal of the Observatory of Mediterranean Basin,
Volume 7 / 2021, pp. 342-348*

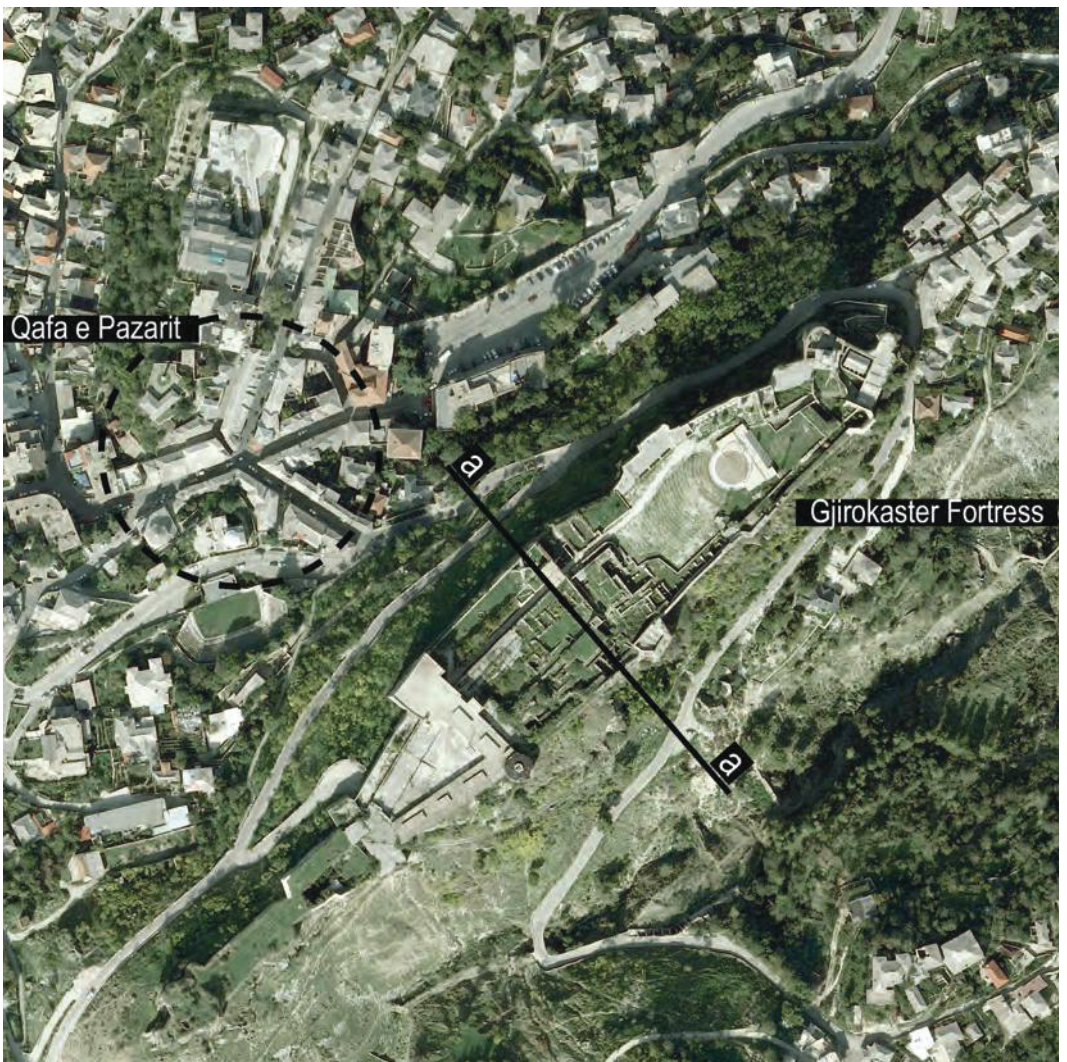
Fig. 2 / Topographical configuration of the fortress area (up) and aerial view of the zone together with the cross- section to be studied (down) (adaptation from the work of Eng. Adriatik Kodra.

A topographical map gives detailed information regarding the configuration of the city in altitude. In order to properly analyze the slope stability a cross-section needs to be generated from the topographical map.

An approximate geological profile for the section a-a shown in Fig2. was elaborated using rough experiences from past studies which show that the fortress itself stands on a strong and well cemented conglomerate with some joints present and a height of around 20-30 meters. Below the conglomerate there are flysch deposits of mainly sandstone and claystone, and on both sides of the hill, just above the flysch, there are deposits of loose to medium dense brown to beige silty clay with a height varying from 3 to 4 meters. The geological configuration

The analysis was performed in three stages: in the first one, the geometry of the slope was generated using the topography, in the second stage all the soil and rock parameters determined in Table 2 were inputted and assigned to the proper layers. In the final stage, according to Fig 2, the analysis was performed using the auto grid option in which a grid of 20 by 20 points was created with the aim of generating a large number of points that serve as centers of potential slip surfaces, each one of them having a different radius. The analysis's results showed that the lowest factor of safety is 1.137, which corresponds to a slip surface passing through the silty clay deposit. By applying a filter for the slip surfaces with a factor of safety lower than 1.2, it can be clearly observed that there are many dangerous surfaces along the conglomerate and flysch deposits too.
