TITLE: **Local Disaster Reduction in the Municipality of Lezha**

AUTHOR: *Dr. Doc. Merita Guri*

SOURCE: *Scientific journal of the Observatory of Mediterranean Basin, Volume 8, Issue 1 & 2 / 2023, pp. 168-177*

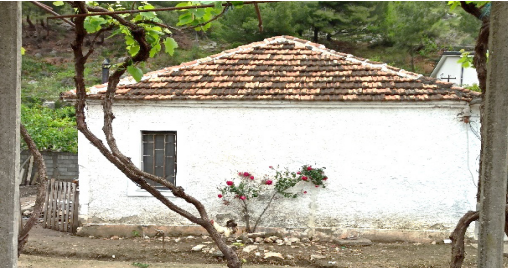
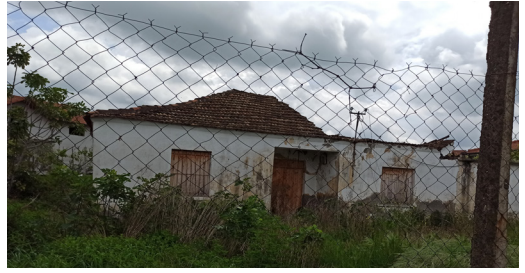
Fig. 5 Examples of structures from 1945 to 1960 in the municipality of Lezhë

During the period between 1945 and 1960, many low-rise buildings were constructed with masonry construction. Few structures were constructed with other materials, such as concrete, steel, or wood.

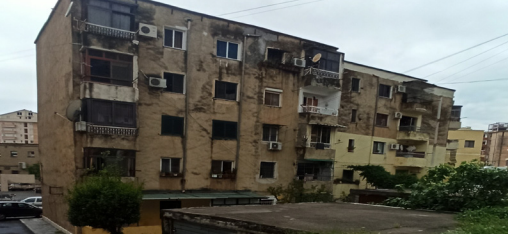
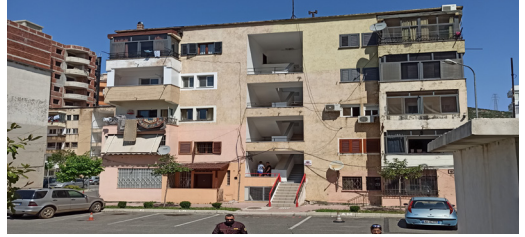
Fig. 6 Examples of structures from 1960 to 1979 in the municipality of Lezhë

2. From 1960 to 1979, as a result of seismic activity, a number of modifications were made to masonry structures: the quality of materials improved significantly, and new structural elements, such as reinforced concrete belts, architraves in windows and doors, and prefabricated and ceramic slabs, were added. Prefabricated structures were introduced as a building

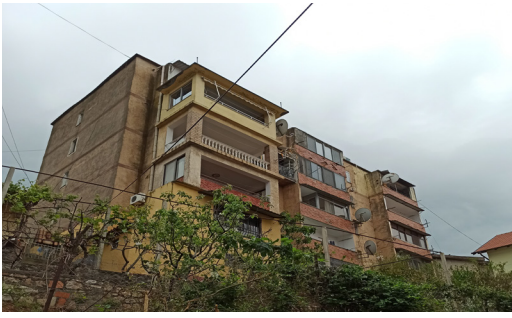
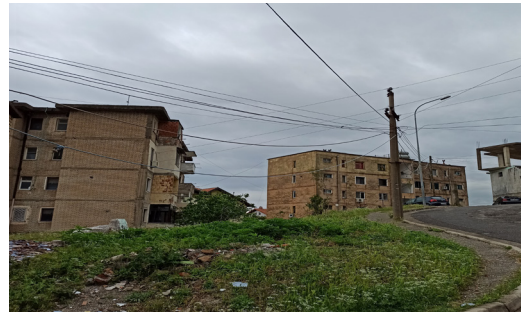
Fig. 7 Examples of structures from 1979 to 1990 in the municipality of Lezhë

From 1979 to 1990, additional enhancements were made to increase the structure's resistance to seismic force. At the corners and intersections of the walls, reinforced iron columns were added and the connections were improved. Each column was secured with anti-seismic cables. In addition to the use of masonry structures, the use of prefabricated buildings persisted. During this time, the first reinforced concrete structure of significant height was constructed in Tirana, a 15-story hotel that continues to operate today.

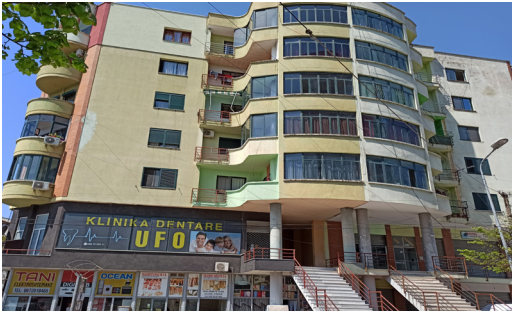
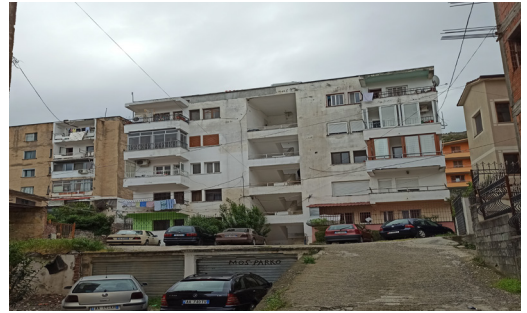
Fig. 8 Examples of structures from 1990 to 2000 in the municipality of Lezhë

From the 1990s to the 2000s, a new construction period is introduced, referring to the structural typology used for low and tall buildings. During this time period, reinforced concrete was widely used and masonry construction ceased.

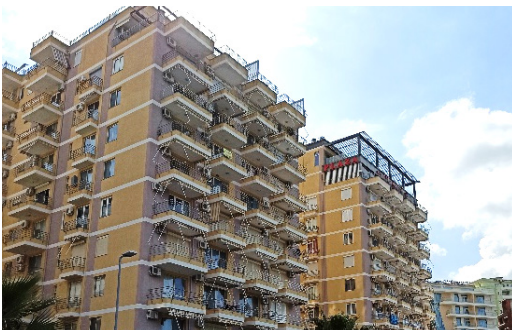
Fig. 9 Examples of structures after the year 2000 in Lezhë municipality

5. With the introduction of the Eurocodes in the year 2000, significant developments were made in relation to the structure's typology, which were centered on the classification provided by this code: reinforced concrete buildings (frames, shear walls, core system), steel buildings, wood and composite buildings.

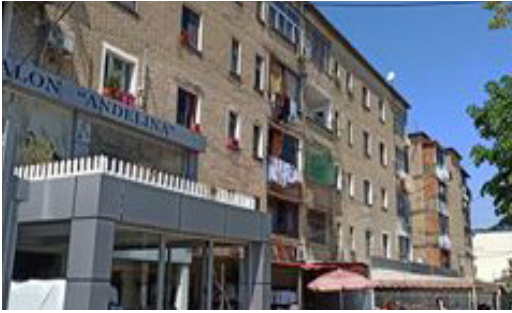
- Existing structures with unreinforced masonry

Between Kosova Street and Gjergj Fishta Boulevard

Along the "Mother Teresa" Boulevard in Shengjin.

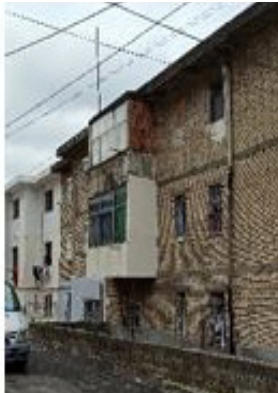
- Existing masonry structures with unreinforced with anti-seismic bands and columns

- "Convenant" area
- "Collection" area

Between Kosova Street and Gjergj Fishta Boulevard

Along the "Mother Teresa" Boulevard in Shengjin.

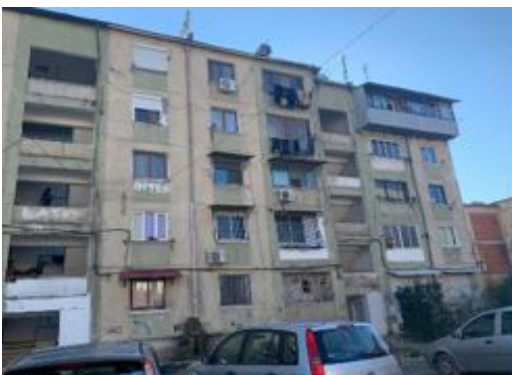
- Prefab buildings

- Along Frang Bardhi street

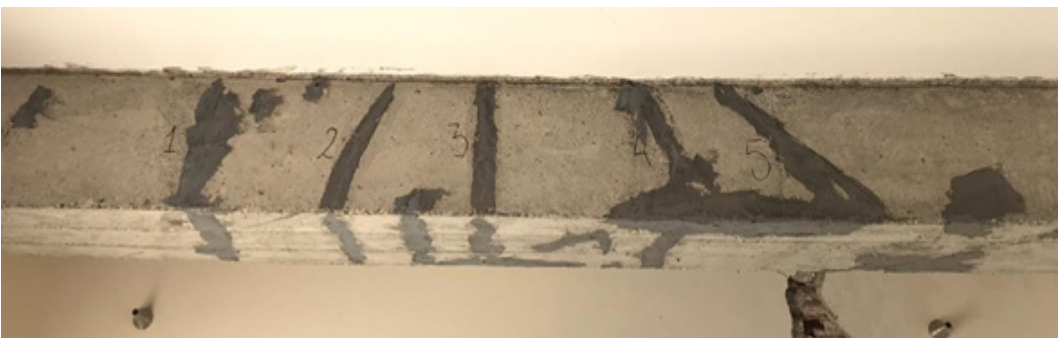
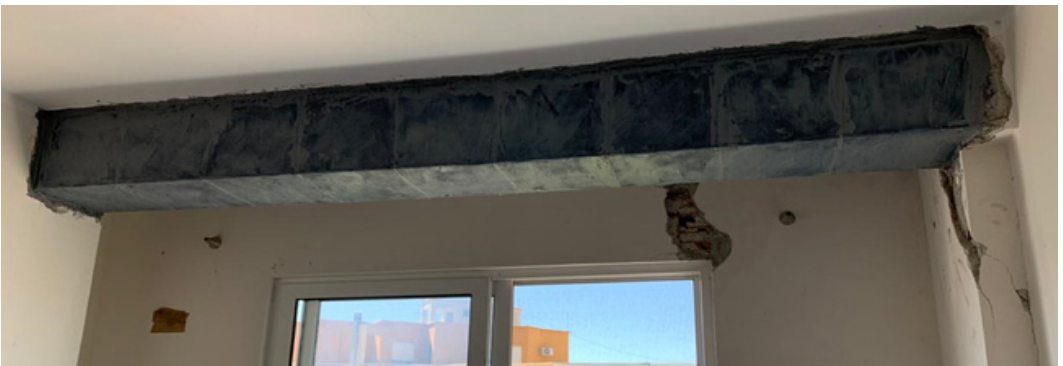
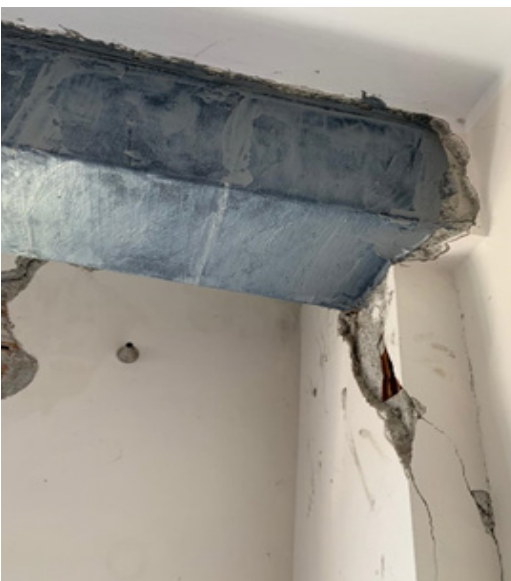
a) Structural damage in the beam b) FRP reinforcement in the beam c) close-up view of the reinforcement d) non-structural damage (partition walls)
