HABITAT 9

TODAY'S CHALLENGES OF CONSTRUCTION INDUSTRY AND RESILIENCE TO NATURAL HAZARDS

PROCEEDINGS BOOK OF THE "TODAY'S CHALLENGES OF CONSTRUCTION INDUSTRY AND RESILIENCE TO NATURAL HAZARDS"

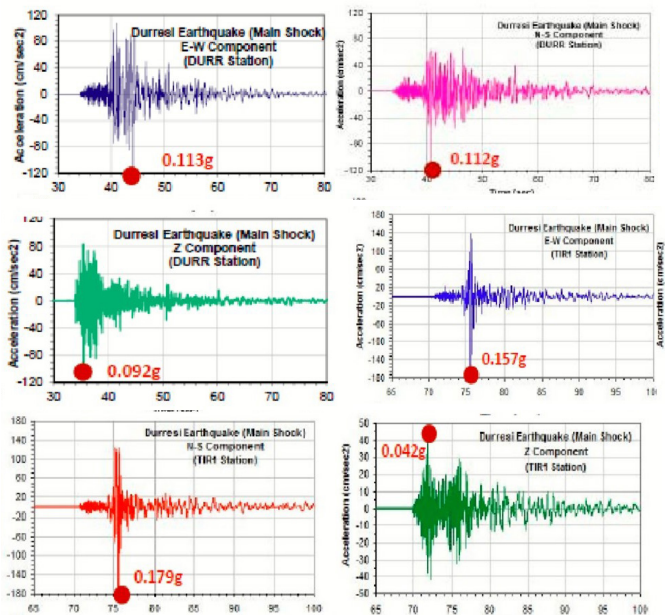
Fig 1. Measurements of the 21 September 2019 Earthquake in Durrës station (upper pictures) and in Tiranë (bottom pictures). In the picture are shown the peak ground horizontal and vertical acceleration in percentage to the gravitational acceleration.

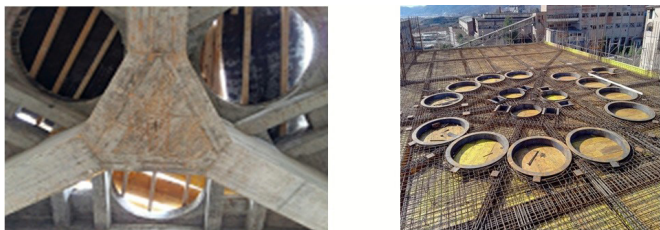
Fig 2. The connection between concrete slabs and silos, some details.

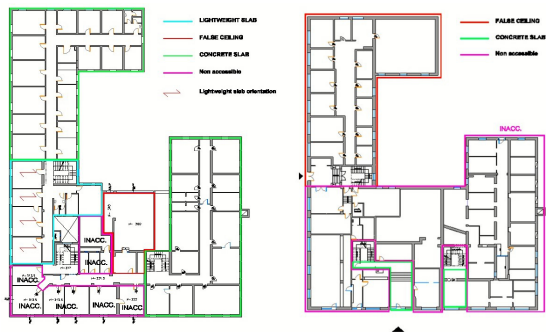
Fig 1. Plans of MZHU building

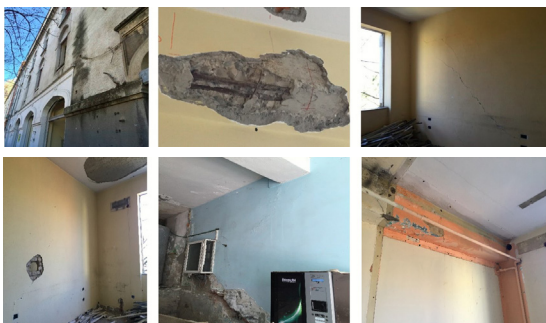
Fig 2. Damages of MZHU building

As shown in the images above, it results that the longitudinal direction of the building is damaged by bending mechanisms and special cutting panels. In transverse direction, all panels are damaged by bending and shearing. Based on these results, we should make concrete column reinforcement, as well as masonry reinforcement. After the reinforcement, it turns out that the building is preserved against all destruction mechanisms and under vertical loads, as well as it will comply with the requirements of European technical conditions.

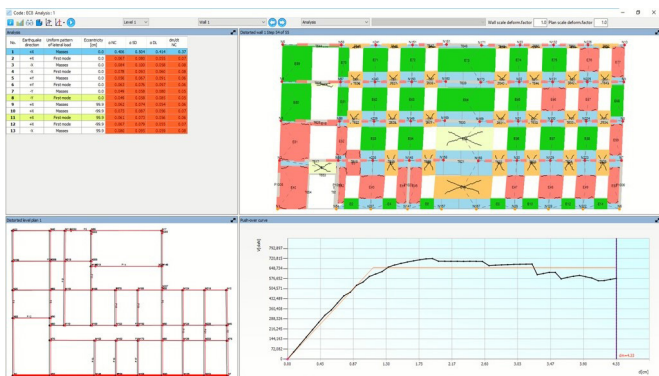
Fig 4. Photo of analysis model of the building

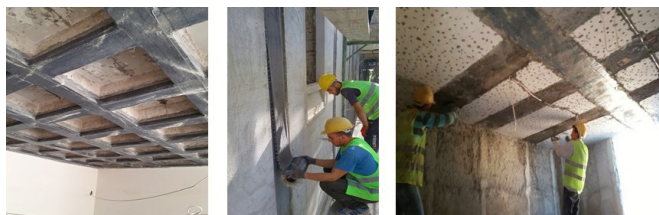
Fig 5. Photos of the building during construction works

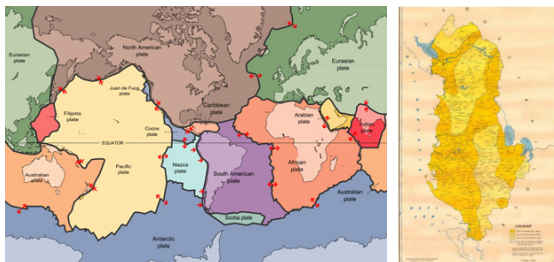
Fig 1. a) Tectonic Plates

b) Tectonic Plates

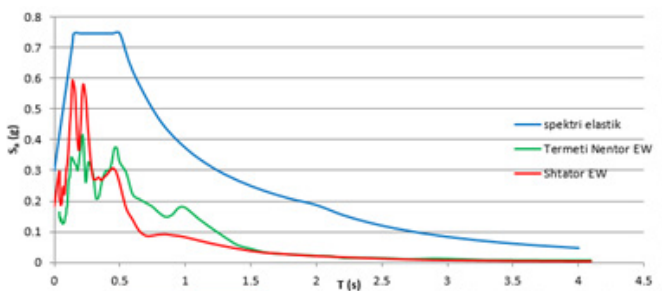
Fig 3. Two response spectra from Tirana 21 September, 26 November compared to the current design code elastic spectrum.

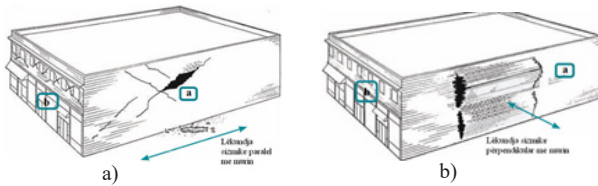
Fig 4. Earthquake Damage of masonry structures: a) In-Plane;
b) Out-of-Plane

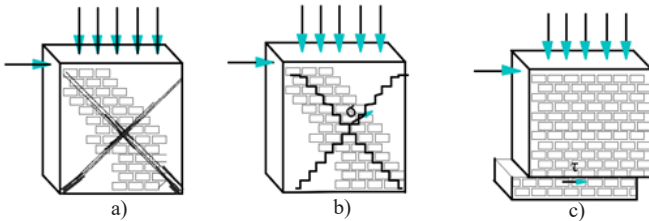
Fig 5. In-Plane Earthquake Damage of masonry structures: a) Diagonal tension shear failure b) Stair-stepped joint shear failure; c) Sliding shear failure.

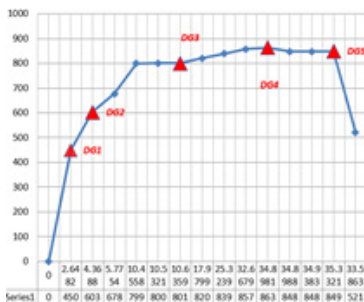
DG5

Damage Grade 1- There is no destruction of any part of the building under the action of biaxial stresses, or very small cracks at the corners of the building cracks or at the top of the walls.

Damage Grade 2- Small destruction under the action of biaxial stresses at the top of the walls or at the corners of the building or in some of its cracks.

Damage Grade 4- Destruction under the action of biaxial stresses at the top of the walls or at the corners of the building or at the bulk of the architraves and between the openings of the building.

Damage Grade 5- Destruction under the action of biaxial stresses in more than 50% of the wall surface and between cracks. These classifications can help engineers and building professionals assess the nature and extent of structural damage to masonry structures and determine the appropriate repair or replacement strategies to ensure the safety and stability of the building.

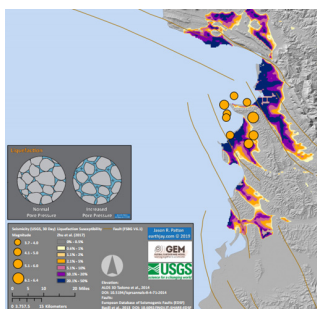
Fig 1. Liquefaction Potential in Durrës area (source: EDSF)

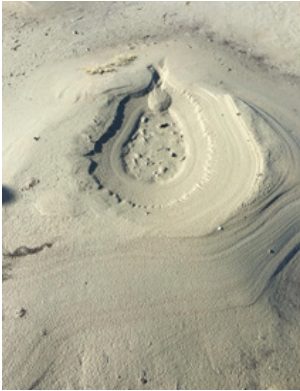
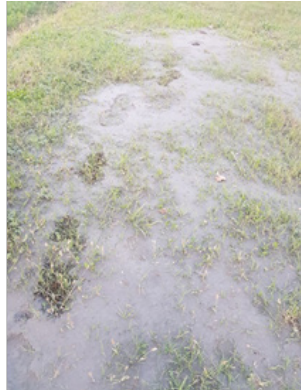
Fig 3. Liquefaction phenomenon in Durrës (Source: Olgert Gjuzi)

After the earthquake of the 26 November, thanks to the many inspections from students and the staff, it was proven that the earthquake, in specific areas shown in Fig.18 has caused the liquefaction phenomenon. Comparing both figures it can be easily observed that the phenomenon appeared exactly in the areas that had the highest potential. Site photos below show depict in a clear way the phenomenon:

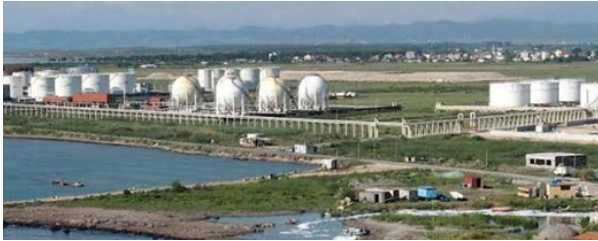
Fig 5. Porto Romano Oil Plant after construction

- Gravel piles under each implant to a depth of 12m to avoid the liquefaction problem.
- Pre- loading using embankment to reduce settlements.
- Vertical drainage in a depth of around 24m to accelerate the effect of the pre-loading (rapid drainage and reducing the time of consolidation settlement).

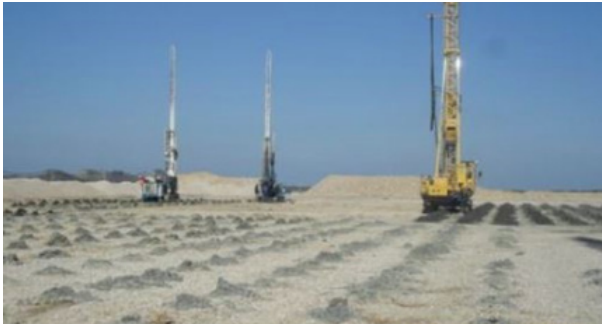
*Fig 6. Drilling of boreholes for vertical drainage system
(Source: Luljeta Bozo)*

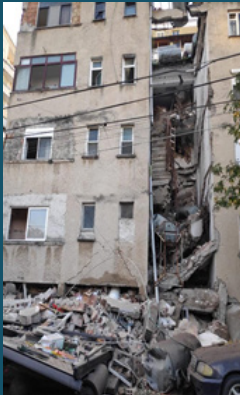
Fig.1 Collapsed structure

Causes that have brought about the total collapse of the structure: Intrusion into the retaining walls of the building mainly on the ground floors (removal, shifting and thinning of the walls. Also geometric modifications to the other floors and closure of the balcony consoles) Destruction of the stair cage as a result of placing water deposits on the cage suite. This extra load, unaccounted for by the designer, under seismic action has caused loss of stability and has helped the global collapse of the entire structure. Degradation of masonry constituent materials, reduction of physical-mechanical parameters of bricks and mortar, also is reduced the retaining capacity of the walls.

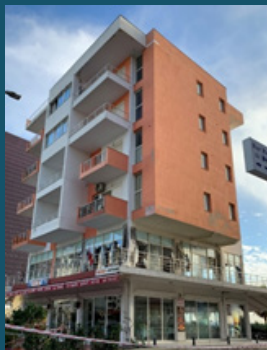
Fig 2. Building near collapse

Inappropriate configuration and orientation of the column plane judging by the geometry of the height structure, also the structural detail, shows insufficient stirrups to withstand seismic force.

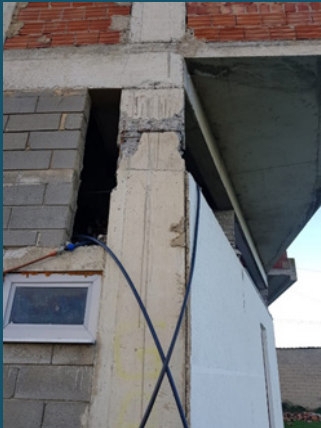
Fig.3 Structural damages, plastic hinges on columns.

Failure to respect the critical areas, at the corner of the columns, for the staff density to be increased in these areas.

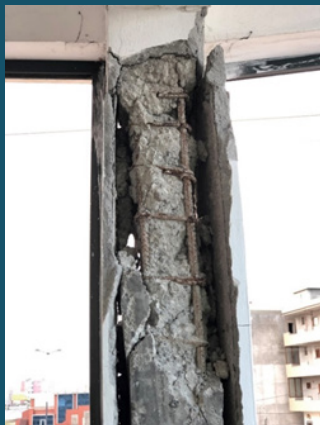
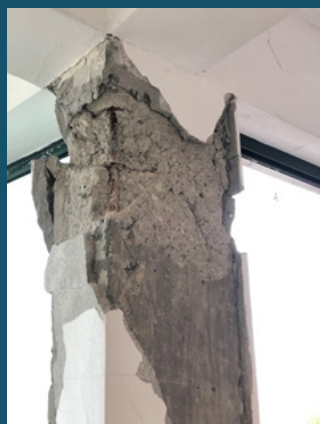
Fig.4 – Structural damages, plastic hinges on columns

Low grade, fully corroded steel that increases its volume. Lack of longitudinal and transverse reinforcement. Failure to respect the critical areas, at the corner of the columns, for the staff density to be increased in these areas

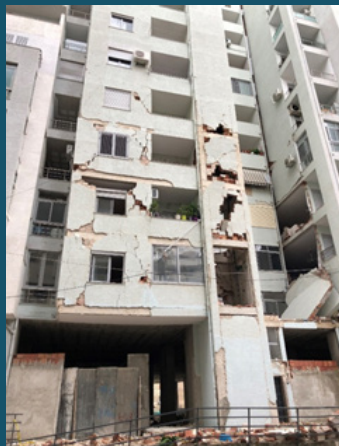
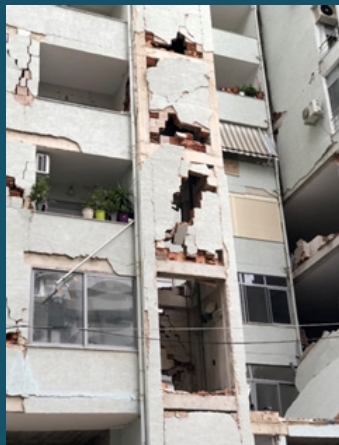
Fig.5 Significant damage to the building with high flexibility

An nonregular configuration of the structure in the plan, which causes the center of mass of the structure to shift. The structure is vulnerable to torsion.

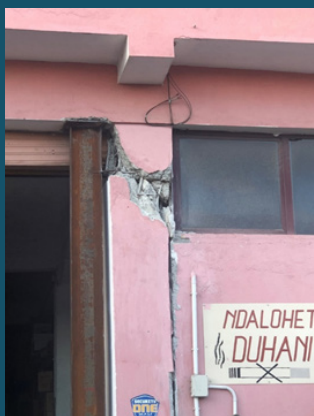
Structural damages
Short columns phenomenon
Damage of column

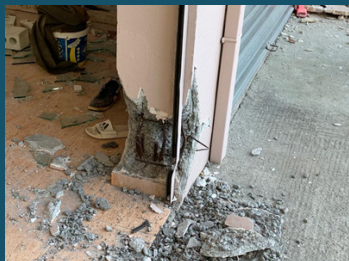
Structural damages
Forming of plastic hinge
Damage of column

Large stirrups spacing in critical regions of columns.
Small overlap length

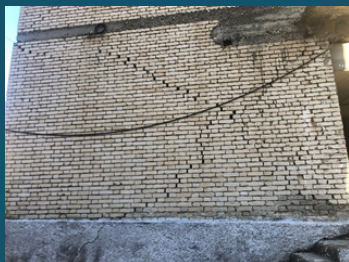
Structural damages
High damages of retaining masonry walls. Damage of mortar

Low thickness of walls
Deterioration of bricks and mortar because of atmospheric agents

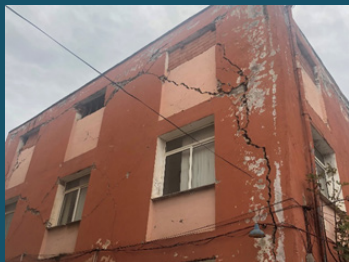
Structural damages
High damages of retaining masonry walls. Damage of mortar

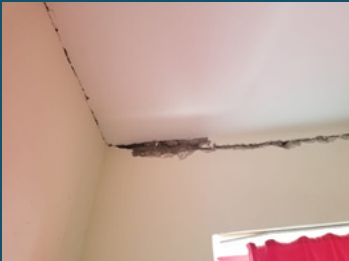
<p>Damage: Disconnecting the connection between the red brick retaining wall and the slab.</p> <p>Cause: Lack of the anti-seismic band. Poor quality in material and working technique. Non-compliance with the rules of technical conditions of implementation (KTZ-89).</p>

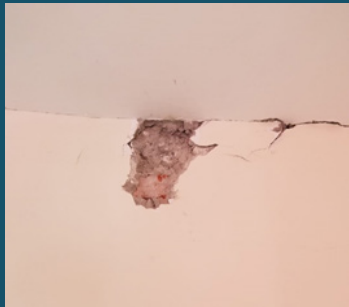
<p>Damage: Local damage to the load bearing wall and its bond to the slab.</p> <p>Cause: Lack of anti-seismic band. Poor quality in material and working technique. Non-compliance with the rules of technical conditions of implementation (KTZ-89). Plastering off standard thickness.</p>

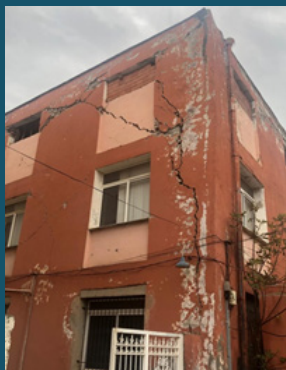
Low masonry ability by cutting forces. Lack of anti-seismic band. Poor quality in material and working technique. Non-compliance with the rules of technical design conditions (KTP - No.2-89, KTZ-89).

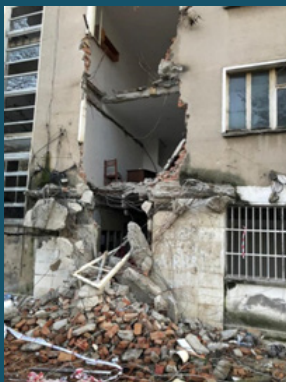
Lack of field geological study.
