**TITLE:** **Excessive presence of Nitrogen and Phosphorus in the Drini River and their impact on the Kune-Vain lagoon ecosystem: how anthropization can affect biodiversity**

**AUTHOR:** *Matteo Bisi*

**SOURCE:** *Scientific journal of the Observatory of Mediterranean Basin, Volume 8, Issue 1 & 2 / 2023, pp. 94-98*

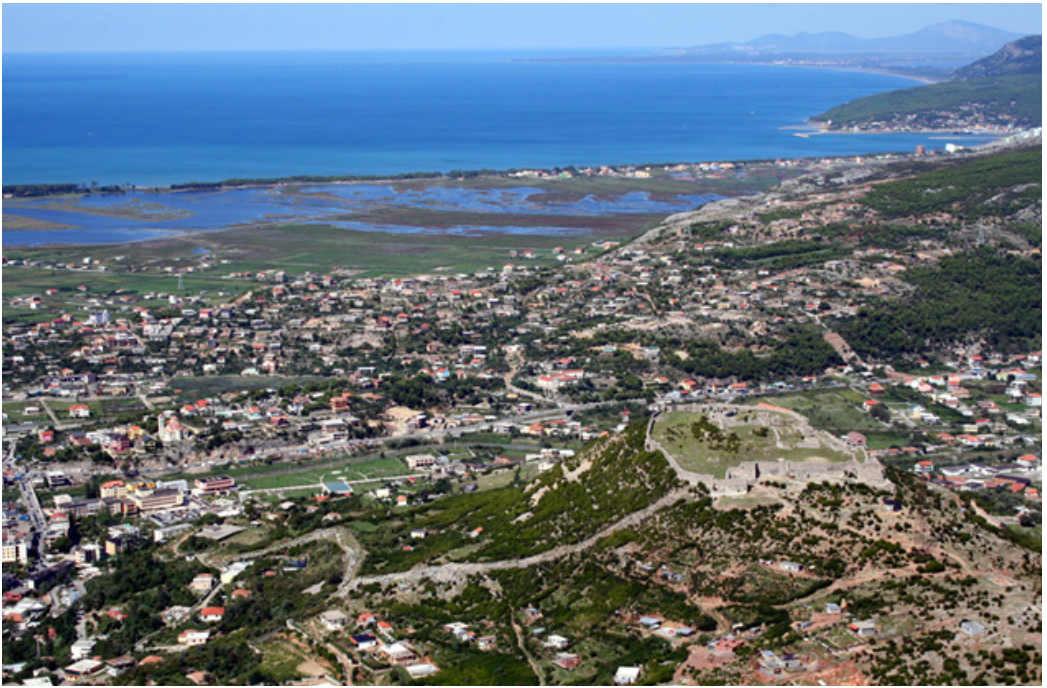
Fig. 3/ Aerial view of the urban area of Lezhë and its interface with the lagoon and the Adriatic Sea

The urban area of the city of Lezhë (Fig3, [www.konica.al](http://www.konica.al)) with a population of 113.535 [[lezha.gov.al](http://lezha.gov.al), 2019:01], is located in proximity of the Kune-Vain Lagoon, becoming an important source for chemical pollutants that infiltrates the ecosystem in many ways.

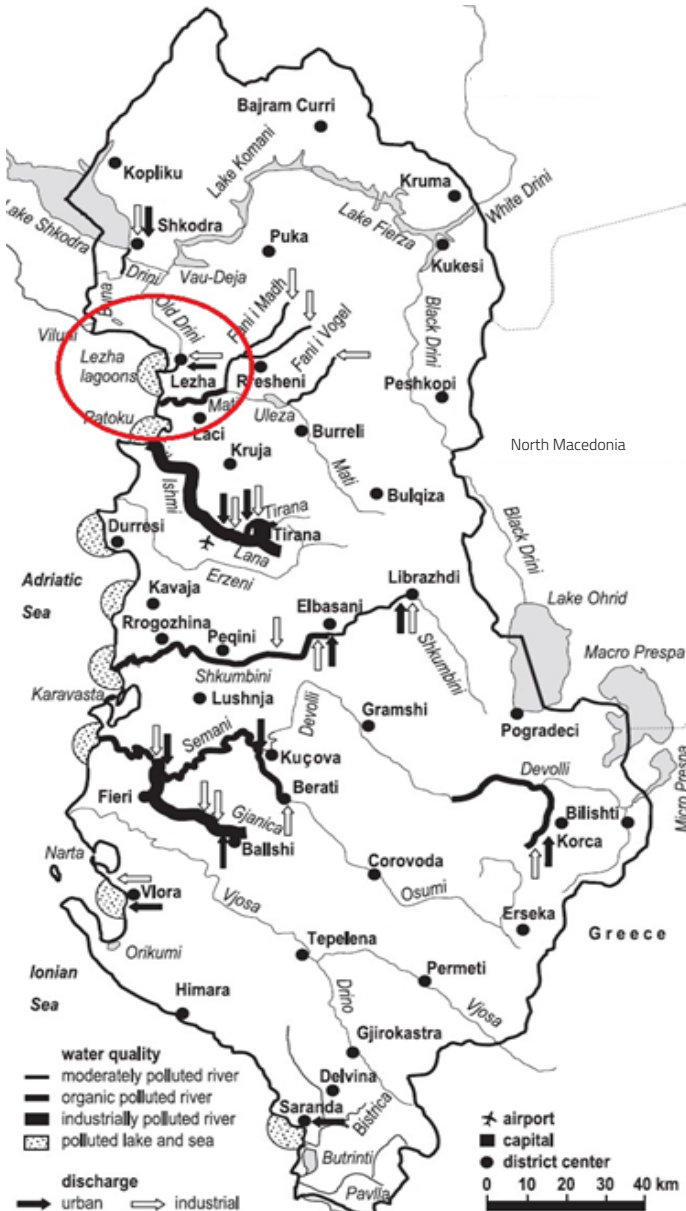
Fig. 4 / Hydrogeological map of the main polluting sites of Albania, highlighting the area of Lezhë. Source: Reinhard Bachofen

role than the others in releasing N and P chemical species into its waters. It has been calculated that about 10 million m<sup>3</sup> of polluted water are released, in many ways, every year into the Drini River [Cullaj, Hasko, Miho, Schanz, Brandl, Bachofen, 2005:139]. Nevertheless, it has to be pointed out that evaluating the water quality condition and its eutrophic status without established thresholds for nutrient concentrations can be very challenging [Clune, Crawford, Boyer, 2020:02]. One of the main causes is associated with the use of land and soil for agricultural purposes and the abandonment of those sites after their exploitation or because they become unsuitable for cultivation: the increasing rate of uncultivated fallow areas of abandoned agricultural sites significantly contribute to the instauration of phenomena like erosion which causes the subsequent runoff of N and P chemical species to streams [Sulçe, Rroco, Malltezi, Shallari, Libohova, Sinaj and Qafoku, 2018:284] and waters that are used for irrigation of other cultivated areas in which fertilization, cultivation and management practices for forage and cereals are present. This leads to an ulterior release of soil particles that are rich in N and P chemical compounds into the aqueous phase of the land. The same process of chemical discharging originates from other main sources such as industrial and mining sites (either still in use or abandoned), making the water surrounding the urban area of Lezhë and its wild habitats (such as the coasts and the Kune-Vain Lagoon) polluted by chemical-organic meanings (Fig4, Environmental International, issue

n°31:2005; drawn modified from UNEP, 2000).
